**ENDANGERED SPECIES ACT-LISTED  
AMPHIBIANS - CALIFORNIA  
RED-LEGGED FROG  
STUDY REPORT  
DON PEDRO PROJECT  
FERC NO. 2299**

**Prepared for:  
Turlock Irrigation District – Turlock, California  
Modesto Irrigation District – Modesto, California**

**Prepared by:  
HDR Engineering, Inc.**

**January 2013**

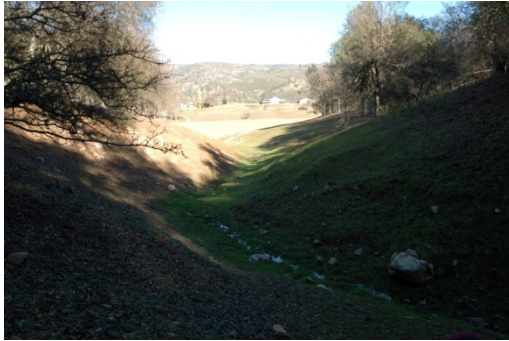
*F1*

F1 is a 58-m-long section of an unnamed tributary, a tributary to the Hatch Creek arm of Don Pedro Reservoir, located partially below the high water line of the reservoir within the FERC Project Boundary. F1 is 2.7 km from the nearest known CRLF occurrence. National Wetlands Inventory (NWI) data (USFWS 2012) depict a riverine, intermittent, streambed, temporarily flooded (R4SBA) wetland feature in the area of the site.

F1 does not hold water for at least 20 weeks during the CRLF breeding season and therefore does not represent potential CRLF breeding habitat.

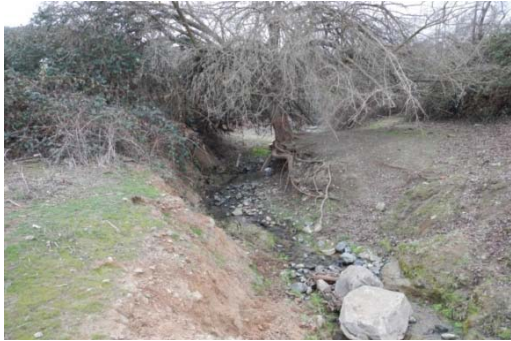
F2 is a 112-m-long section of an unnamed intermittent tributary to Don Pedro Reservoir, located approximately 65 m west of Marsh Flat Road, partially below the high water line of Don Pedro Reservoir, and within the FERC Project Boundary. F2 is 2.5 km from the nearest known CRLF occurrence. NWI data depict F2 as a riverine, intermittent, streambed, seasonally flooded (R4SBC) wetland feature.

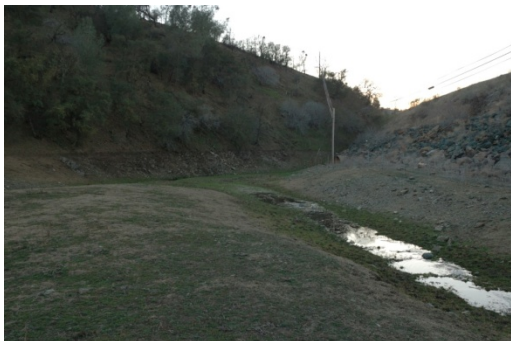
F3 is a freshwater pond formed at the confluence of three perennial tributaries to Don Pedro Reservoir, located east of SR 182, 65 m east of Don Pedro Reservoir, and within the FERC Project Boundary. F3 is 4 km from the nearest known CRLF occurrence. NWI data for the area depict a palustrine, unconsolidated bottom, permanently flooded, diked/impounded (PUBHh) wetland feature in the area of the site.

The site was assessed on February 8, 2012. The bank full width was estimated at 1.5 m with a maximum depth of 0.5 m. The stream gradient was approximately 3 percent. Pools measuring up to 5 m x 1.5 m and 0.1 m deep were present at the site. Non-pool habitat was made up of riffles. Substrate consisted of silt. Banks were gently sloping with an incised vegetated channel. The dominant emergent and margin vegetation was grass with no overhanging vegetation present. Surrounding upland habitat consisted of blue oak (*Quercus douglasii*) pastureland. A juvenile American bullfrog was observed during the survey.

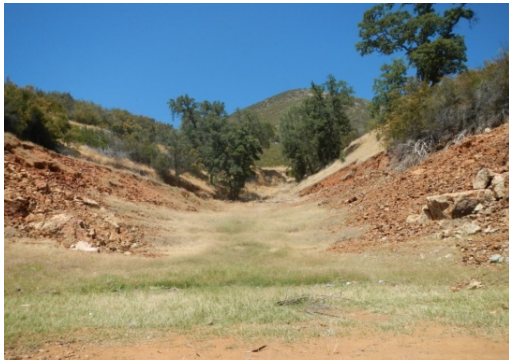
F8 is a 45-m-long section of an ephemeral tributary to the upper bay of Don Pedro Reservoir, below the high water line of Don Pedro Reservoir within the FERC Project Boundary. F8 is 10 km from the nearest known CRLF occurrence. NWI data for the area depict a riverine, intermittent, streambed, temporarily flooded (R4SBA) wetland feature in the area of the site.

was 1 m with a depth of 0.25 m. The stream gradient was 4 percent. The stream was dry at the time of survey, but it was assumed that no pools were present. Non-pool habitat was assumed to be riffle during flow conditions. The substrate was made up of soil and bedrock with some cobbles. The stream bank varied from gently sloping to steep bedrock and cobbles with grass present in flat areas. Emergent and margin vegetation consisted of grasses and forbs below the high water line, with buckthorn and oak in the upland and overhanging the stream channel in some areas. No fish or amphibians were observed; however, fish are known to be present in Don Pedro Reservoir.

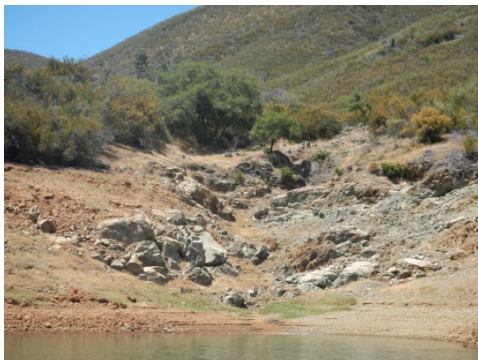
F9 is a 37-m-long section of an ephemeral tributary to the upper bay of Don Pedro Reservoir, below the high water line of Don Pedro Reservoir within the FERC Project Boundary. F9 is 9.8 km from the nearest known CRLF occurrence. NWI data for the area depict a riverine, intermittent, streambed, temporarily flooded (R4SBA) wetland feature in the area of the site.

was 2 m with a depth of 1 m. The stream gradient was 6 percent. The stream was dry at the time of survey, but it was assumed that pools would be present during flow conditions. Non-pool habitat was assumed to be a mix of cascade, riffle, and step-pool. The substrate was made up of soil and grasses that were present throughout the stream channel. Stream banks consisted of somewhat steep bedrock. Emergent and margin vegetation consisted of grasses, with one oak overhanging the stream channel. Upland habitat was dominated by buckthorn (*Ceanothus* sp.). No fish or amphibians were observed; however, fish are known to be present in Don Pedro Reservoir.

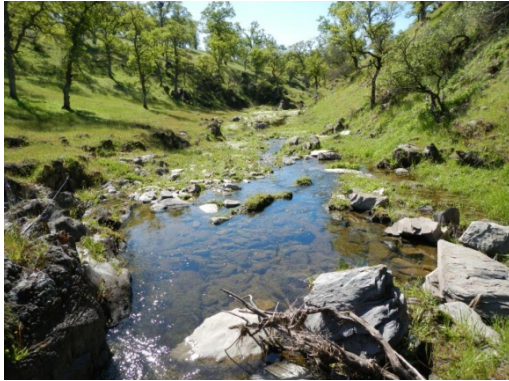
**F11**

F11 is a 591-m-long section of West Fork Big Creek, a perennial tributary to Don Pedro Reservoir, located partially below the high water line of Don Pedro Reservoir within the FERC Project Boundary. F11 is 17 km from the nearest known CRLF occurrence. NWI data for the area depict a riverine, intermittent, streambed, seasonally flooded (R4SBC) wetland feature in the area of the site.

Pools measuring up to 2 m x 5 m and 0.75 m deep were present in the stream. Non-pool habitat consisted of riffle, run, and step-pool. The substrate was made up of bedrock and cobbles. Stream banks varied from low gradient to steeper areas of vegetated soil with some bedrock outcroppings. Emergent vegetation was a mix of grasses and forbs, with willow overhanging the site. Upland habitat was made up of oak, a few pines, and shrubs. American bullfrogs and small fish were observed at the site during the survey.

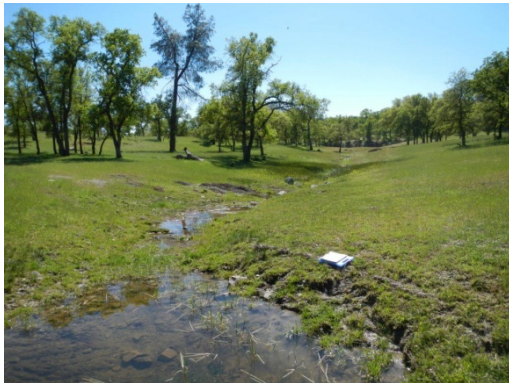
**F12**

F12 is a 58-m-long section of an unnamed perennial tributary to the Big Creek arm of Don Pedro Reservoir, located 40 m northeast of Don Pedro Reservoir within the FERC Project Boundary. F12 is 8.7 km from the nearest known CRLF occurrence. NWI data for the area depict a riverine, intermittent, streambed, seasonally flooded (R4SBC) wetland feature in the area of the site.

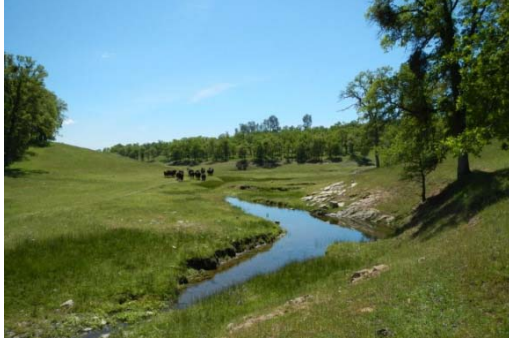
F13 is a 736-m-long section of an unnamed perennial tributary to 49er Bay, located 15 m south of Old Don Pedro Road, partially below the high water line of Don Pedro Reservoir and within the FERC Project Boundary. F13 is 7.3 km from the nearest known CRLF occurrence. NWI data for the area depict a riverine, intermittent, streambed, seasonally flooded (R4SBC) wetland feature in the area of the site.

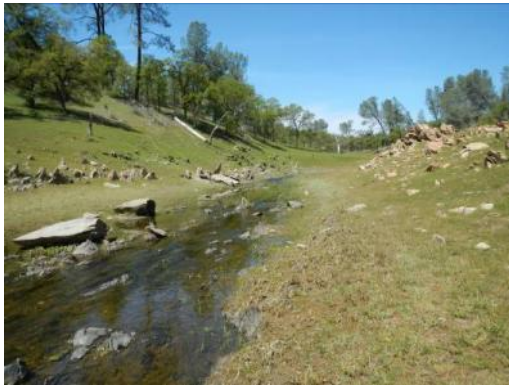
F15 is a 1,218-m-long section of Big Creek and associated tributaries, located partially below the high water line of Don Pedro Reservoir within the FERC Project Boundary. F15 is 12.2 km from the nearest known CRLF occurrence. NWI data for the area depict a riverine, intermittent, streambed, seasonally flooded (R4SBC) wetland feature from the mouth at the reservoir upstream.

bank full width of the stream was observed to be 7 - 8 m with a depth of 0.5 m. The stream gradient was 2 - 4 percent. Pools measuring up to 1 m x 3 m and 1.5 m deep were present in the stream. Non-pool habitat consisted of riffle, run, and cascade. The substrate was made up of bedrock, gravel, cobble, and boulder. Stream banks were low gradient near the stream, turning to steeper rolling hills. Emergent and margin vegetation were a combination of grasses and forbs with no vegetation overhanging the site. Upland habitat was a mixed oak and foothill pine savannah with approximately 45 percent canopy cover. Juvenile and larval American bullfrogs were present throughout the site, and 3 western toads were observed in amplexus during the survey. A bald eagle was observed feeding on a bass near the stream with a juvenile or subadult nearby. Horses were observed grazing near the stream.

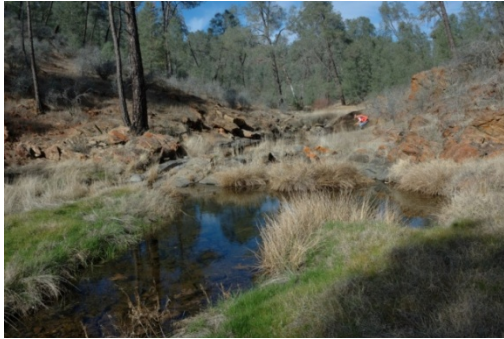
*F17*

F17 is a 187-m-long section of Poor Man's Gulch, below the high water line of Don Pedro Reservoir within the FERC Project Boundary. F17 is 12.8 km from the nearest known CRLF occurrence. NWI data for the area depict a riverine, intermittent, streambed, seasonally flooded (R4SBC) wetland feature in the area of the site.

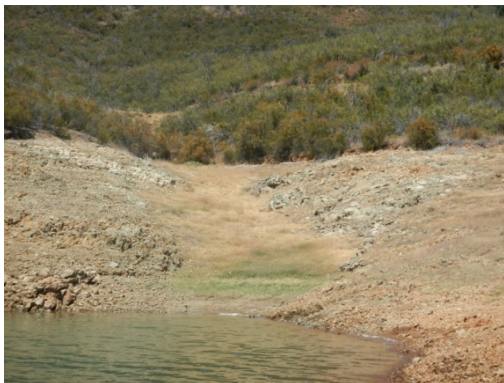
*F19*

F19 is a 26-m-long section of an ephemeral tributary to the upper bay of Don Pedro Reservoir, below the high water line of Don Pedro Reservoir within the FERC Project Boundary. F19 is 9.8 km from the nearest known CRLF occurrence. NWI data for the area depict a riverine, intermittent, streambed, temporarily flooded (R4SBA) wetland feature in the area of the site.

The site was assessed on June 19, 2012. F19 is in the vicinity of seven other ephemeral tributaries to the upper bay of Don Pedro Reservoir. The bank full width was 7 m with a depth of 1 m, but the channel was not well defined. The stream gradient was 6 percent. The stream was dry at the time of survey, but it was assumed that no pools would be present. Non-pool habitat was assumed to be riffle during flow conditions. The substrate was made up of soil and grasses that were present throughout the stream channel. Stream banks were gently sloping bedrock and gravel. Emergent and margin vegetation consisted of grasses, with buckthorn and other scrub/shrubs in the upland and overhanging the stream channel in the upstream portion of the site. No fish or amphibians were observed; however, fish are known to be present in Don Pedro Reservoir.

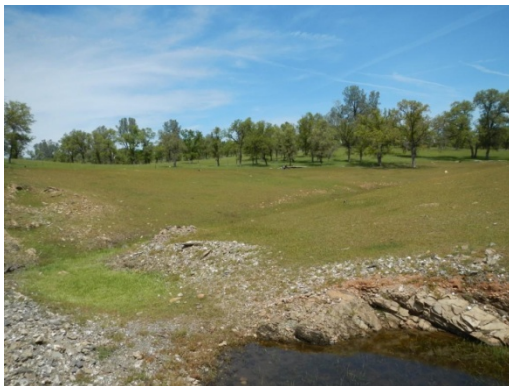
F22 is a 145-m-long section of an unnamed perennial tributary to the Big Creek arm of Don Pedro Reservoir, located 10 m north of Don Pedro Reservoir within the FERC Project Boundary. F22 is 9.1 km from the nearest known CRLF occurrence. NWI data for the area depict a riverine, intermittent, streambed, seasonally flooded (R4SBC) wetland feature in the area of the site.

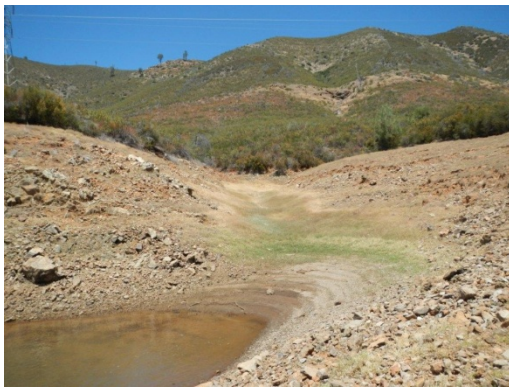
F23 is a 48-m-long section of an ephemeral tributary to the upper bay of Don Pedro Reservoir, below the high water line of Don Pedro Reservoir within the FERC Project Boundary. F23 is 9.6 km from the nearest known CRLF occurrence. NWI data for the area depict a riverine, intermittent, streambed, temporarily flooded (R4SBA) wetland feature in the area of the site.

The site was assessed on June 19, 2012. F23 is in the vicinity of seven other ephemeral tributaries to the upper bay of Don Pedro Reservoir. The bank full width was 7 - 10 m with a depth of 2 - 3 m. The stream gradient was 4 percent. The stream was dry at the time of survey, but it was assumed that no pools would be present. Non-pool habitat was assumed to be riffle during flow conditions. The substrate was made up of soil and grasses that were present throughout the stream channel. Stream banks were gently sloping and vegetated, and become increasingly rocky towards the top of the slope. Emergent and margin vegetation consisted of grasses, with Manzanita and buckthorn in the upland and overhanging the stream channel in some areas. No fish or amphibians were observed; however, fish are known to be present in Don Pedro Reservoir.

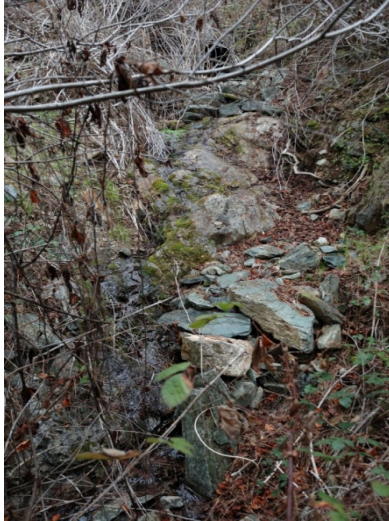
F26 is a 70 m-long section of an unnamed intermittent tributary to Don Pedro Reservoir, located perpendicular to Grizzly Road, partially below the high water line of Don Pedro Reservoir and within the FERC Project Boundary. F26 is 12.1 km from the nearest known CRLF occurrence. NWI data for the area depict a riverine, intermittent, streambed, temporarily flooded (R4SBA) wetland feature from the mouth at the reservoir upstream, including Site F26.

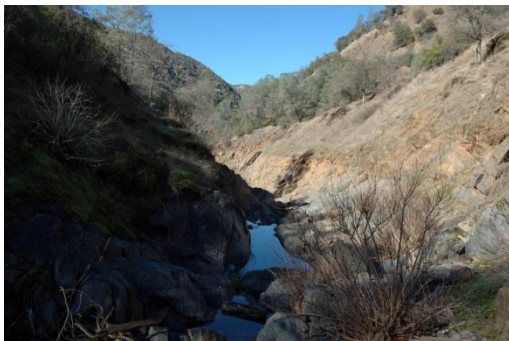
F27 is a 278-m-long section of Deer Creek, a perennial tributary to Don Pedro Reservoir, located south of Wards Ferry Road, partially below the high water line of Don Pedro Reservoir, and within the FERC Project Boundary. F27 is 17 km from the nearest known CRLF occurrence. NWI data for the area depict a riverine, intermittent, streambed, seasonally flooded (R4SBC) in the area of the site.

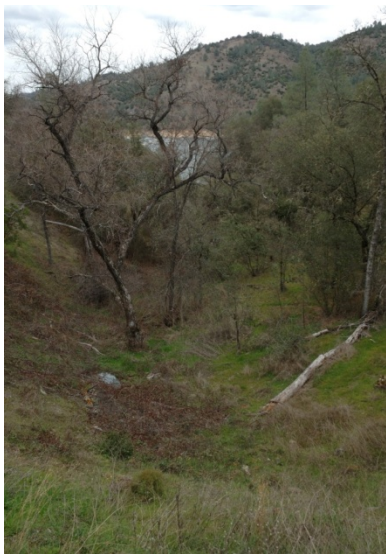
*F31*

F31 is a 238-m-long section of an unnamed seasonal tributary to Don Pedro Reservoir, located northeast of US Hwy 120/49 near Moccasin Point Marina, partially below the high water line of Don Pedro Reservoir, and within the FERC Project Boundary. F31 is 11.7 km from the nearest known CRLF occurrence. NWI data for the area depict a riverine intermittent, streambed, temporarily flooded (R4SBA) wetland feature upstream of the where the stream joins the river, including Site F31.

consisted of riffle, but the stream was mostly dry at the time of the survey with some seepage at the culvert. Substrate was made up of angular cobble. The stream was channelized with incised banks, especially upstream of the culvert. Downstream of the culvert, no channel was visible at the time of the survey. No emergent vegetation was present, but the margins were vegetated with blackberry and upland grasses. Blackberry was overhanging the stream. Surrounding upland habitat included foothill pine, oak, and Manzanita (*Arctostaphylos* sp.). No fish or amphibians were observed; however, fish are known to be present in Don Pedro Reservoir.

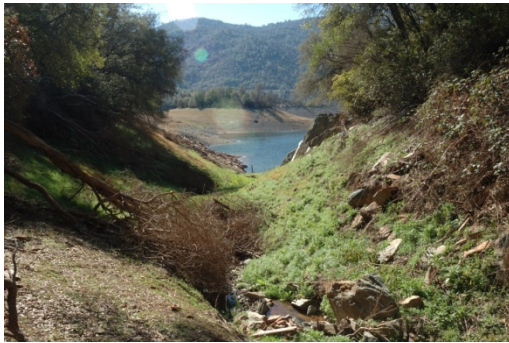
F32 is a 114-m-long section of an unnamed perennial tributary to Don Pedro Reservoir, located southwest of Jacksonville Road, 5 m north of Don Pedro Reservoir, and within the FERC Project Boundary. F32 is 13.7 km from the nearest known CRLF occurrence. NWI data for the area depict a riverine, intermittent, streambed, temporarily flooded (R4SBA) wetland feature upstream of the where the stream joins the river, including Site F32.

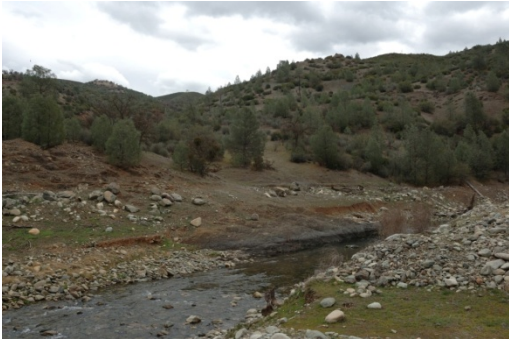
F33 is an 88-m-long section of an unnamed seasonal tributary to Don Pedro Reservoir, located south of Grizzly Road, partially below the high water line of Don Pedro Reservoir, and within the FERC Project Boundary. F33 is 11 km from the nearest known CRLF occurrence. NWI data for the area depict a riverine, intermittent, streambed, temporarily flooded (R4SBA) wetland feature upstream of the where the stream joins the river, including Site F33.

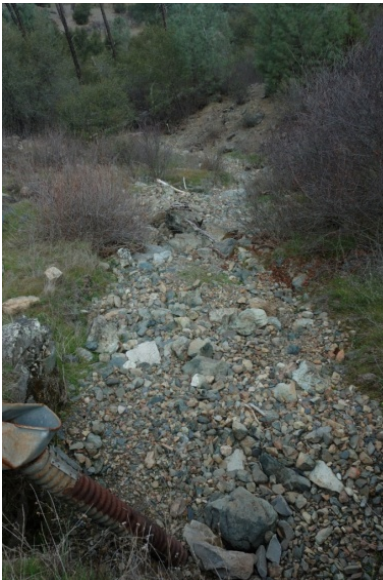
F34 is a 353-m-long section of an unnamed seasonal tributary to Don Pedro Reservoir, located south of Moccasin Creed D Road, partially below the high water line of Don Pedro Reservoir, and within the FERC Project Boundary. F34 is 10.7 km from the nearest known CRLF occurrence. NWI data for the area depict a riverine, intermittent, streambed, temporarily flooded (R4SBA) wetland feature from the mouth at the reservoir upstream including Site F34.

mainly consisted of cobble, but boulders, gravel and large woody debris were also present. Banks were sloping and made up of incised soil. The dominant bank and margin vegetation was a mix of upland grasses and willow, with emergent upland aster present and willows overhanging the stream. Surrounding upland habitat included a mix of foothill pine and oak woodland with willow along the banks of the stream. No fish or amphibians were observed; however, fish are known to be present in Don Pedro Reservoir.

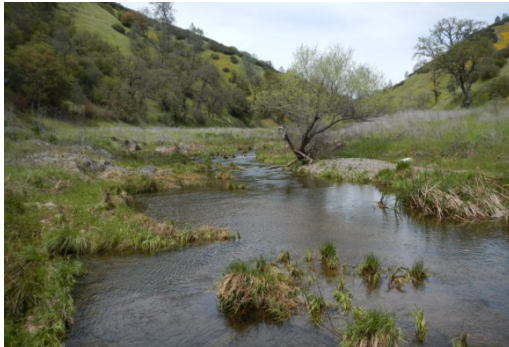
F35 is a 173-m-long section of Woods Creek, located below the high water line of Don Pedro Reservoir within the FERC Project Boundary. F35 is 13.6 km from the nearest known CRLF occurrence. NWI data for the area depict a lacustrine, littoral, unconsolidated shore, seasonally flooded, diked/impounded (L2USCh) wetland feature in the area of the site.

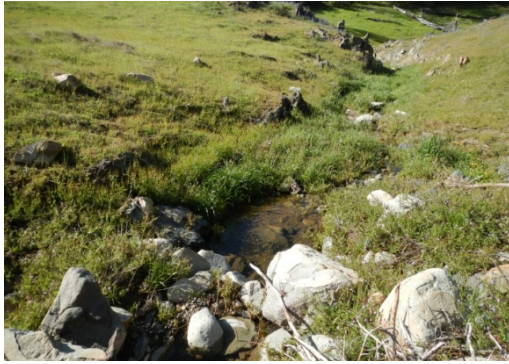
F36 is a 78-m-long section of a seasonal unnamed tributary to Don Pedro Reservoir, located below the high water line of Don Pedro Reservoir within the FERC Project Boundary. F36 is 1.9 km from the nearest known CRLF occurrence. NWI data for the area depict a lacustrine, limnetic, unconsolidated bottom, permanently flooded, diked/impounded (L1UBHh) wetland feature in the area of the site.

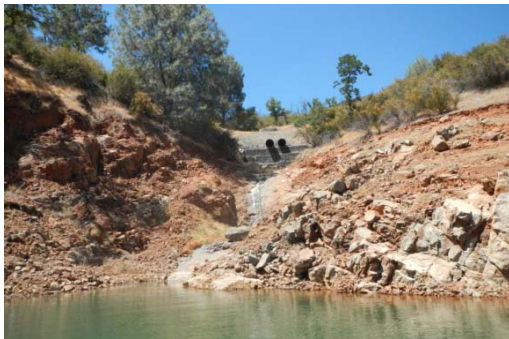
F38 is a 43-m-long section of an ephemeral tributary to the upper bay of Don Pedro Reservoir, below the high water line of Don Pedro Reservoir within the FERC Project Boundary. F38 is 10.1 km from the nearest known CRLF occurrence. NWI data for the area depict a riverine, intermittent, streambed, temporarily flooded (R4SBA) wetland feature in the area of the site.

The site was assessed on June 19, 2012. F38 is in the vicinity of seven other ephemeral tributaries to the upper bay of Don Pedro Reservoir. The stream flowed from parallel culverts that cross a BLM road over rock face with no defined channel. The stream was dry at the time of survey, but it was assumed that two pools would be present during flow conditions. Non-pool habitat was assumed to be cascade. The substrate was made up of soil and grasses that were present throughout the stream channel. The bank consisted of cobbles on the bedrock outside of the rock face. Emergent and margin vegetation consisted of desiccated grasses, with buckthorn and other scrub/shrubs in the upland and overhanging the stream channel.

in some areas. A few scattered oak and pine were also present in the upland. No fish or amphibians were observed; however, fish are known to be present in Don Pedro Reservoir.

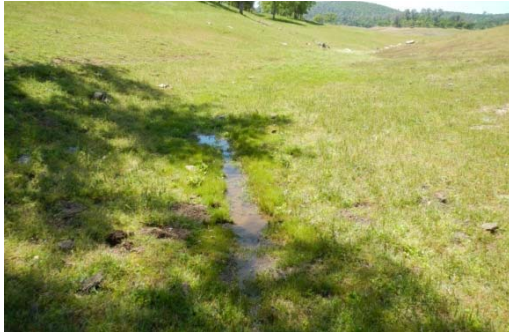
F39 is a 24-m-long section of a seasonal unnamed tributary to Don Pedro Reservoir's 49er Bay, 185 m northwest of Don Pedro Reservoir within the FERC Project Boundary. F39 is 6.4 km from the nearest known CRLF occurrence. NWI data for the area depict a riverine, intermittent, streambed, temporarily flooded (R4SBA) wetland feature in the area of the site.

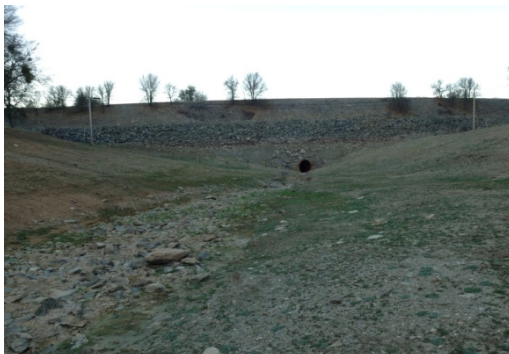
F40 is a palustrine freshwater pond, located south of US Hwy 132, below the high water line of Don Pedro Reservoir and within the FERC Project Boundary. F40 is 4.4 km from the nearest known CRLF occurrence. NWI data for the area depict a palustrine, unconsolidated shore, seasonally flooded, diked/impounded (PUSCh) wetland feature in the area of the site.

The site was assessed on February 8, 2012. F40 is a pond located above a culvert within a gently sloping drainage. The site covers approximately 14,300 m<sup>2</sup>; the maximum observed water depth was greater than 2 m; the bank full depth was greater than 2 m. The pond was dry at the time of assessment. Substrate consisted of soil, silt, bedrock, and boulders. Emergent vegetation consisted of sparse grass and forbs, the dominant vegetation in the area. No vegetation was

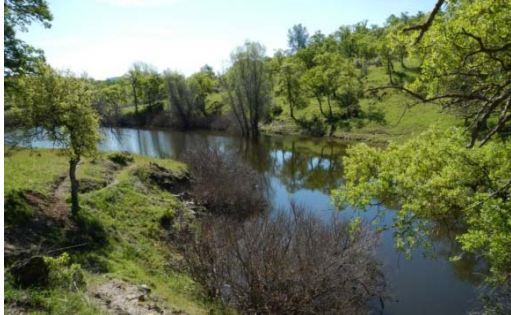
*F43*

F43 is a palustrine, freshwater pond created by a natural impoundment within West Big Fork Creek, located below the high water line of Don Pedro Reservoir and within the FERC Project Boundary. F43 is 9.6 km from the nearest known CRLF occurrence. NWI data for the area depict a palustrine, unconsolidated bottom, permanently flooded, diked/impounded (PUBHh) wetland feature in the area of the site.

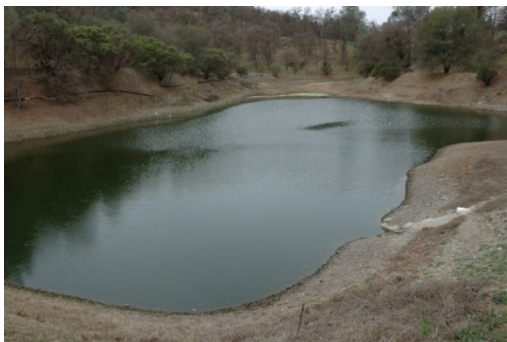
F51

some algae was observed at the inflow. Upland habitat was made up of oak woodland, foothill pine, and Manzanita.
